Conference Paper, Published Version

Geobags for Riverbank Protection

K. Oberhagemann *, M.A. Stevens**, S.M.S. Haque***, and M.A. Faisal***

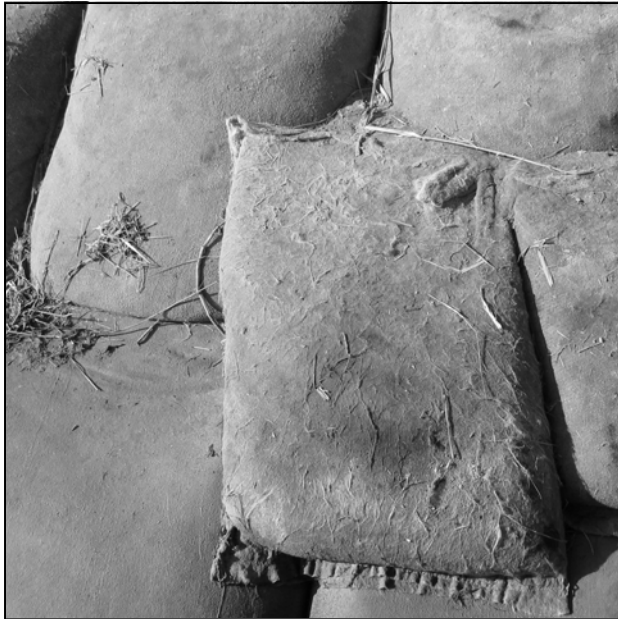
FIGURE 4

DIFFERENT TYPES OF GEOBAGS PLACED AS TEMPORARY WAVE PROTECTION. NOTE THE ABRASION OF THE BAG SURFACE OF THE BAG ON TOP

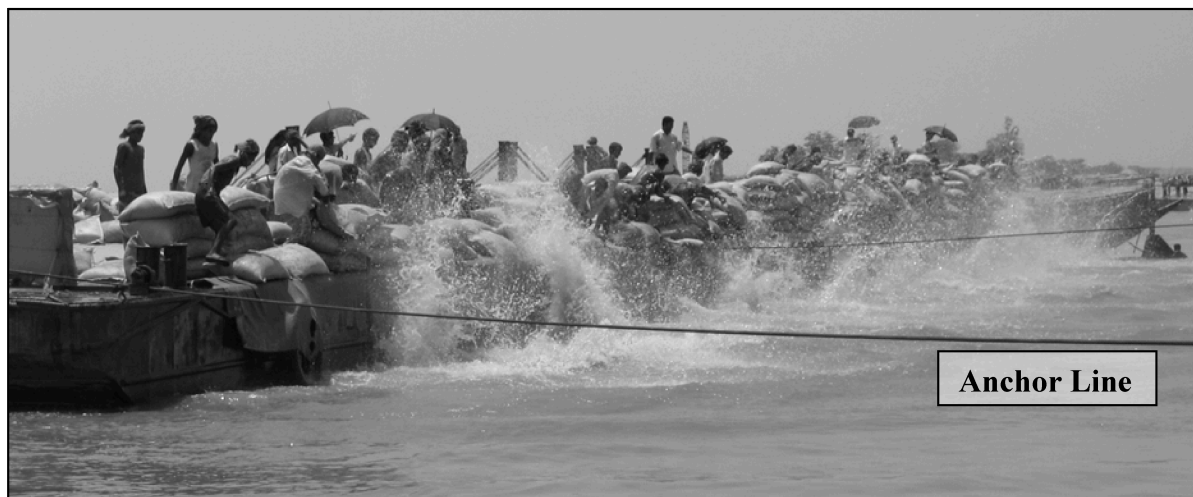
FIGURE 7
1ST LEVEL PROTECTION DUMPED FROM POSITIONED BARGES

First level protection: A three-bag layer is placed over the launched bags making, on the average, a four-layer thickness on the slope after completion of this first level protection (Fig. 7). In addition, a thin and wide falling apron for the expected future scour is placed at the toe of this protection. Lately, 12 to 15 m wide falling aprons are built consisting of three layers of bags. This falling apron can cover up to 15 m scour depth.

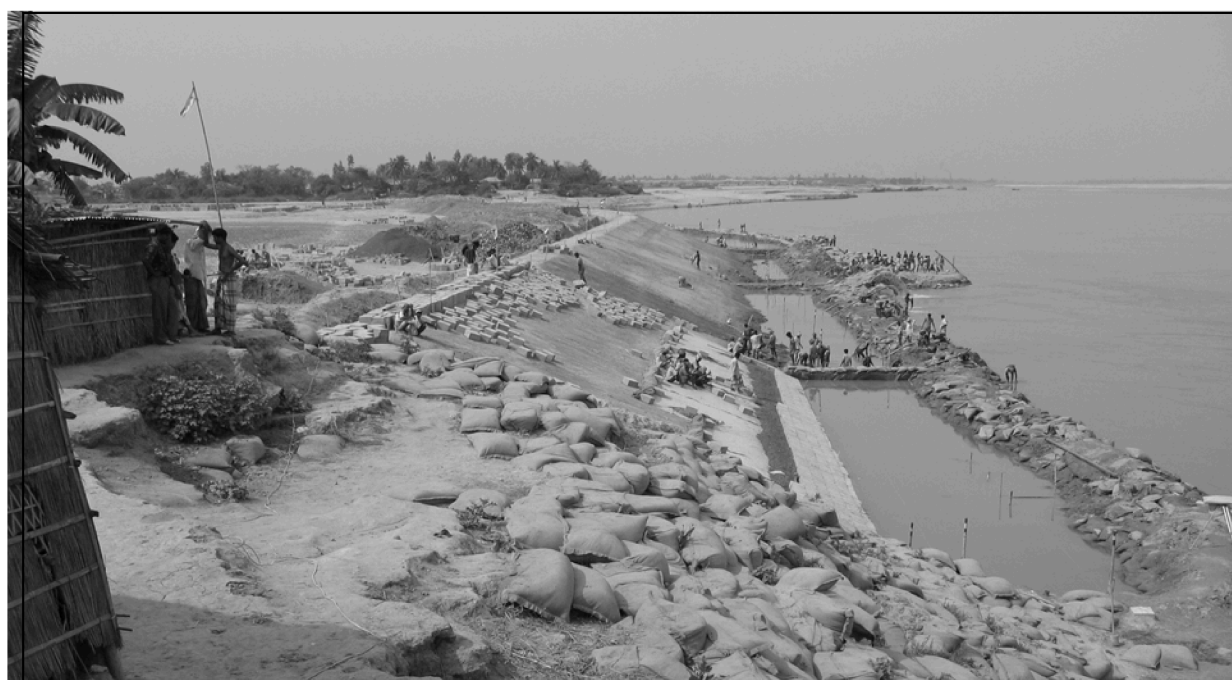
FIGURE 8
CONSTRUCTION OF PERMANENT WAVE PROTECTION ABOVE LOW WATER LEVEL DURING THE ADAPTATION PHASE

Adaptation: The river response to protection commonly results in toe scour along revetments. For this purpose falling aprons are placed along the toe. These falling aprons may have to be upgraded to first level protection after their deployment. In addition to depth changes, the erosion can shift in upstream or downstream direction. In these cases, immediate and first level protection will be repeated for areas under new attack.
